Photographic Log

Site Name:
Collierville High School

Tracking No.:
TN0081787

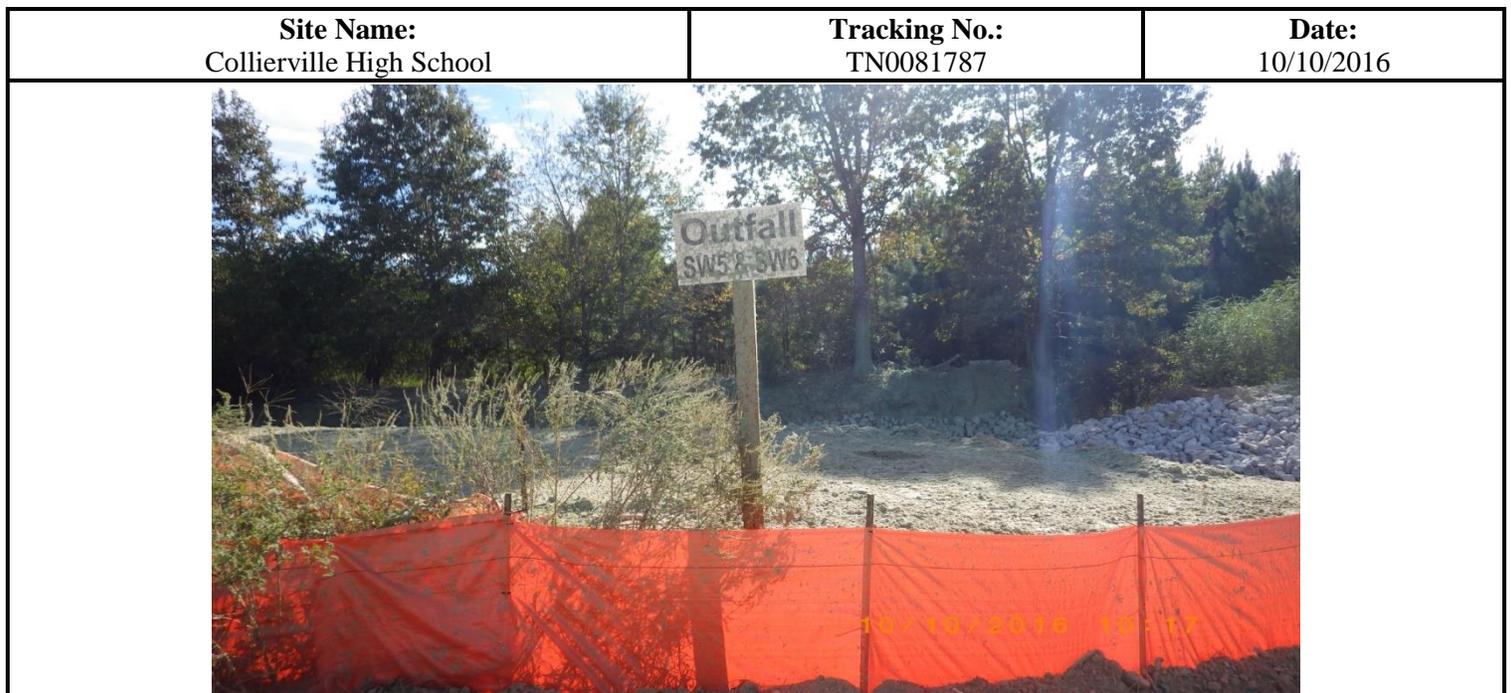
Photo 1. Sign identifying the approximate location of Outfalls SW5 and SW6 near the bank of the unnamed tributary of Nonconnah Creek.
